Radiation Safety Evaluation of some CT Units in Zliten city, Libya

This study was conducted from January to June 2024, to measure radiation leakage and scatter from CT-scan departments in two selected public diagnostic centers in Zliten: Souq al-Thola'tha Polyclinic-Zliten and Naima Hospital of Emergencies and Accidents-Zliten. The objective was to quantify radiation leakage and scatter from CT suites and to assess compliance with design and safety requirements.

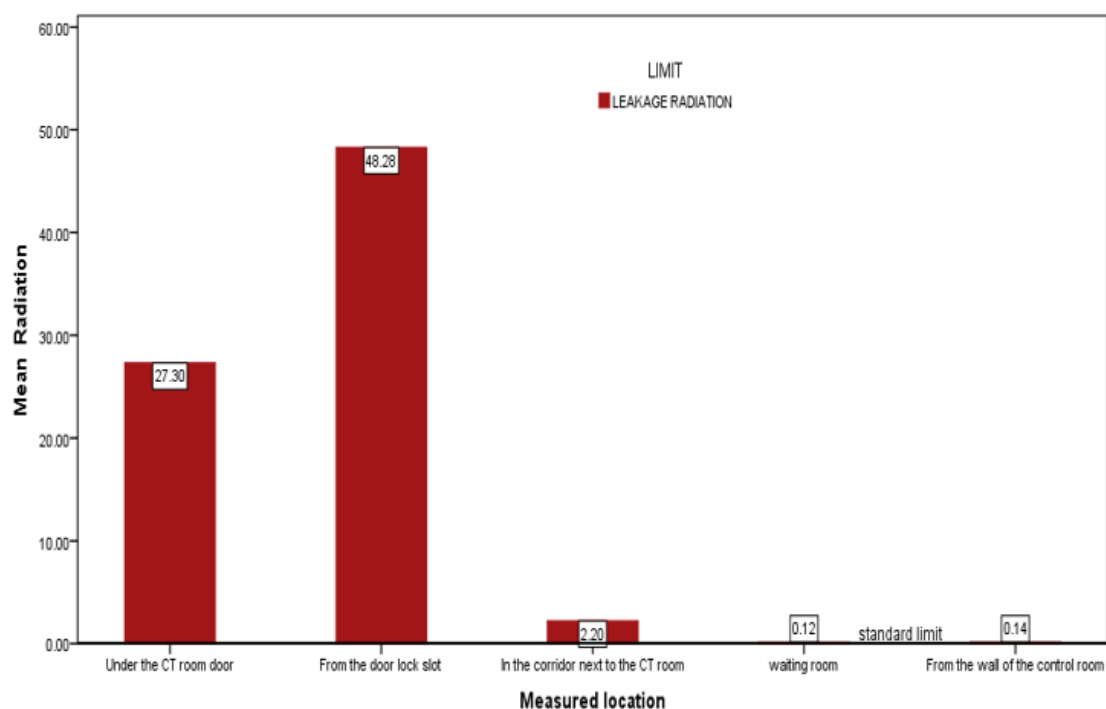
Figure (1): Average amounts of radiation in Souq-althola'tha Polyclinic (CT-scan)-Zliten

The data shown in Figure 1 present the measured dose rates for diagnostic tomography. These results indicate significant radiation leakage from the main door of the CT room: dose rates measured at the bottom of the door ranged from 8.50 to 51.23 $\mu\text{Sv/h}$. The door's clearance from the floor is approximately 2 cm, so lead strips should be added to the door.

Measurements at the door-lock opening ranged from 24.8 to 74.25 $\mu\text{Sv/h}$ at exposure parameters of 150 kV and tube currents of 200 and 250 mA, indicating that the door is not adequately shielded. Door misalignment also contributes to elevated leakage in the corridor, with values exceeding normal limits (1.53–2.97 $\mu\text{Sv/h}$). These dose rates could pose a risk to the public because they would contribute toward the recommended annual effective dose limit for the general public (1 mSv/year).

The results are shown in a table (1). the results showed the presence of radiation leakage in all areas of the Souq-althola'tha Clinics Complex (CT-scan) in Zliten, exceeding 0.08 µSv/h. It was found that the average value of the radiation leakage ranged between 0.12 µSv/h and 48.28 µSv/h. Measurements showed that the area (From the door lock slot) recorded the largest average value at 48.28 µSv/h, which does not comply with the advisory level as it exceeded very significantly 0.08 µSv/h, while the (waiting room) area recorded the lowest average value amounting to 0.12 µSv. /h, which does not correspond to the heuristic level. Also, it was noted that the average value of the radioactive leakage did not reach the indicative level and exceeded 0.08 µSv/h in all areas, (From the door lock slot-Under the CT room door-In the corridor next to the CT room-From -waiting room, recorded 48.28, 27.3, 2.2, and 0.12 µSv/h, respectively:

Patient waiting seats were originally located in the corridor opposite the CT-room door. Officials were notified and the waiting area was relocated; subsequent measurements at the new location were 0.03–0.07 $\mu\text{Sv/h}$, which are within normal background levels and considered safe.

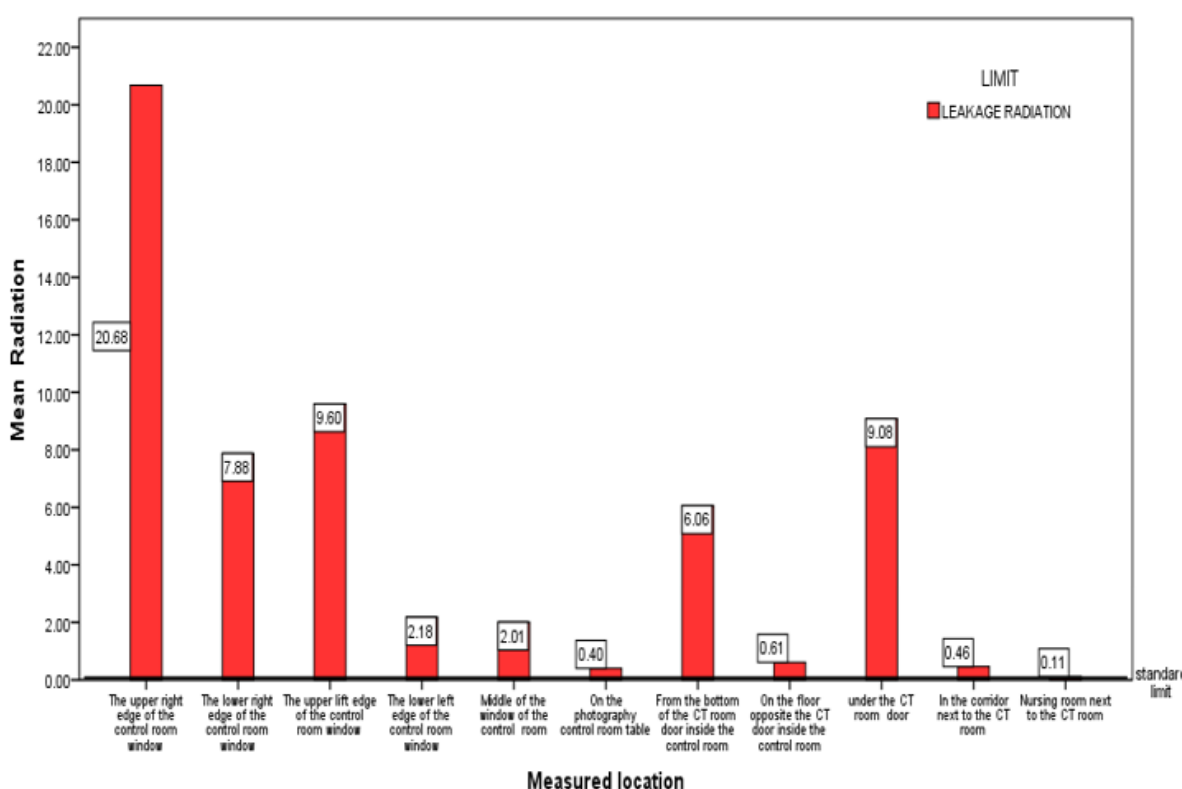
Figure (2): Average amounts of radiation in Naima Hospital of Emergencies and accidents-Zliten.

Measured dose rates from the survey results for Naima Emergency and Accident Hospital are shown in figure 2. All measurements from the control room's window, particularly from the upper right side, as well as from the door separating the control room and the radiology room, were higher than expected and above normal levels.

The measurement under the entrance door for patients in the CT room revealed dose rates ranging from (6.38 $\mu\text{Sv/h}$ to 11.78 $\mu\text{Sv/h}$) at exposure factors of 120 kV and currents of 30 - 250 mA, respectively, as a result of the height of the lower door opening from the ground about 2 cm. This situation necessitates the addition of lead strips to prevent radiation leakage from beneath the door, which is not properly closed and requires maintenance.

Similarly, the lower part of the door separating the control room and the radiology room recorded a dose of 6.06 $\mu\text{Sv/h}$, signaling a need for lead strips to mitigate leakage. Dose rates from the control room's window were alarmingly high, ranging from (2.01-20.68 $\mu\text{Sv/h}$), which is unacceptable for optimal radiation protection. Given the average of patients per day (25 patients), personal exposure doses for technicians may exceed permissible values, necessitating the replacement of the current window with one composed of thicker.

Table (2) showing the results showed a radiation leakage in all areas of Naima Accident Hospital in Zliten that exceeded 0.08 $\mu\text{Sv/h}$. It was found that the value of the average radiation leakage ranged between 0.11 $\mu\text{Sv/h}$ and 20.68 $\mu\text{Sv/h}$., as measurements showed that:
